## **THE SUPPORT OF UNDERWATER WORKS WITH THE USE OF REMOTELY OPERATED VEHICLES ON THE EXAMPLE OF WORKS CONDUCTED ON THE WRECK OF THE FISHING BOAT WŁA-127**

Marek Dawidziuk<sup>1)</sup>, Adam Olejnik<sup>2)</sup>

### **ABSTRACT**

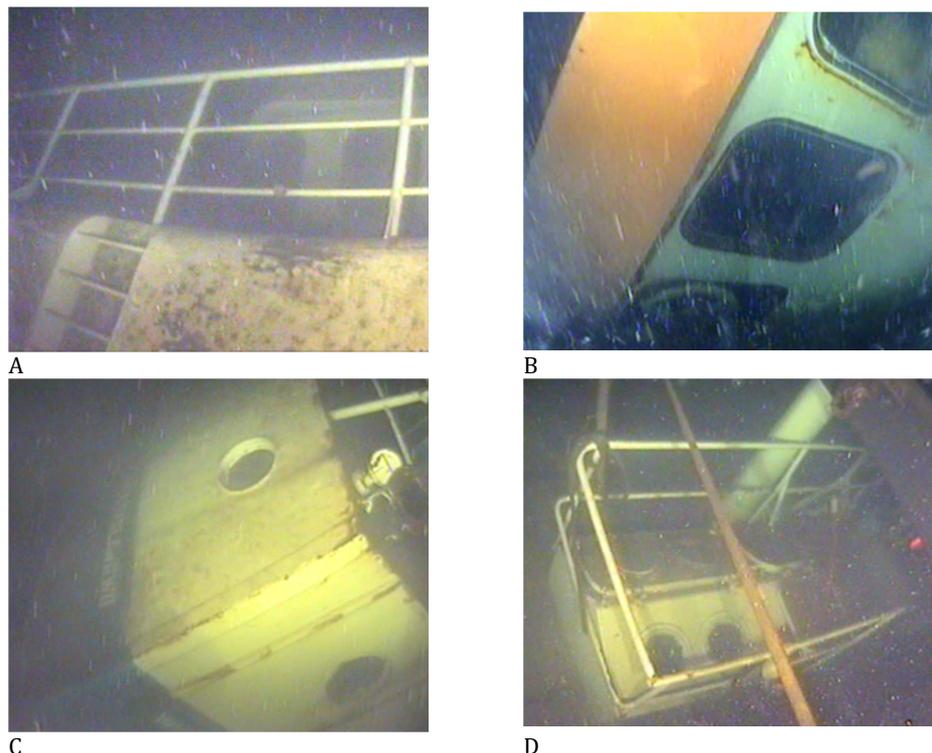
Fig. 4. Structure elements of the sunken boat shown in underwater position using the vision system installed on the Falcon ROV (own studies). A – companionway on the port side amidships, B – superstructure, C – stern, D – stern, engine room skylights.

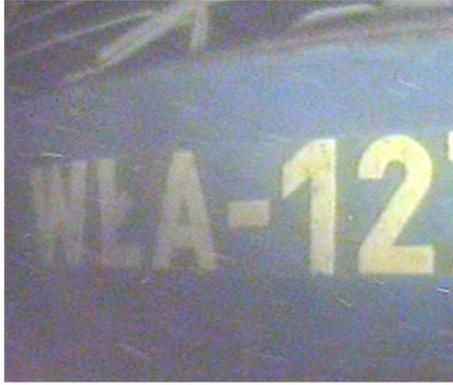
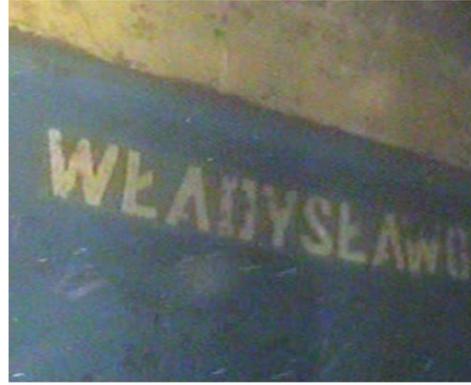
The definitive element confirming the identification of the wreck sought was the well-visible name of the wreck "WŁA-127" on the bow section of the widoczna nazwa wraku „WŁA-127” w części dziobowej na lewej burcie i desce trałowej, jak również nazwa portu pochodzenia „WŁADYSŁAWO” na jego rufie (Rys. 5). port side and trawl board as well as the name of the port of origin "WŁADYSŁAWO" on its stern (Fig. 5).

Fig. 5. Identification inscriptions on the hull of the sunken boat (own research).

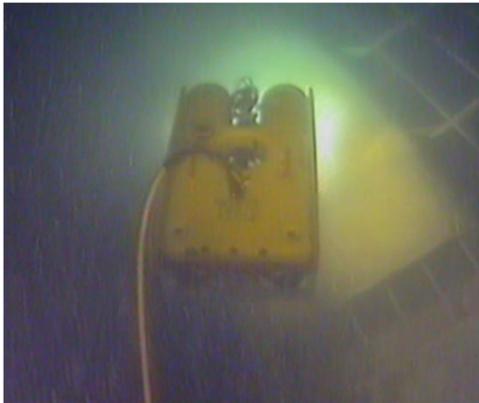
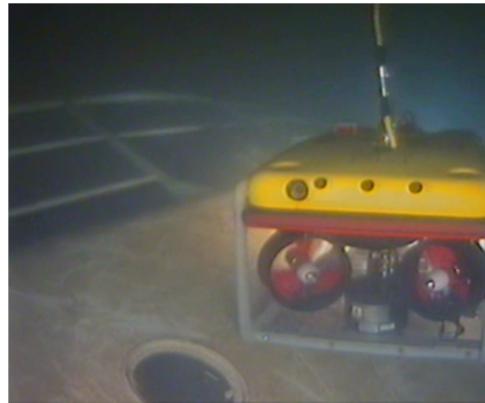
An inspection of the outer hull was initiated with a visual inspection on the port side of the wreck (Fig. 6). The first surveyed areas were the midships and the bow section. The inspection consisted in an assessment of the

shell condition for any dents, damage, leaks, or the condition of the fishing boat equipment.

Fig. 6. The Falcon ROV during WLA-127 wreckage inspection (own studies).

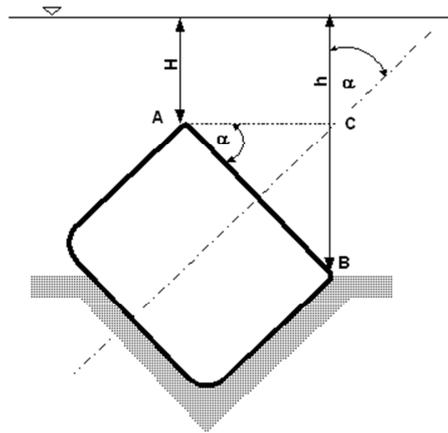
One of the tasks carried out during the inspections was to determine the angle of heel of the wreck by the ROV operator. Analysis of the pictures of the stem and mast allowed only an estimation of this angle. Additionally, using the vertical propulsion drive, the vehicle was "glued" to the ship's side to read the vehicle's tilt angle from the on-board navigational unit which then corresponded to the tilt angle of the wreck. Measurement of this parameter was also made indirectly using the methodology based on two depth measurements conducted with the use of the vehicle's on-board devices (Fig. 7).

Fig. 7. Graphical representation of the wreck position for calculating its heel angle based on two depth measurements (schematic diagram without a scale).

A depth gauge mounted on the vehicle was used to measure depths at point A and point B, then using the known AB value and simple trigonometric relations (1), (2) the hull angle of the wreck was calculated.

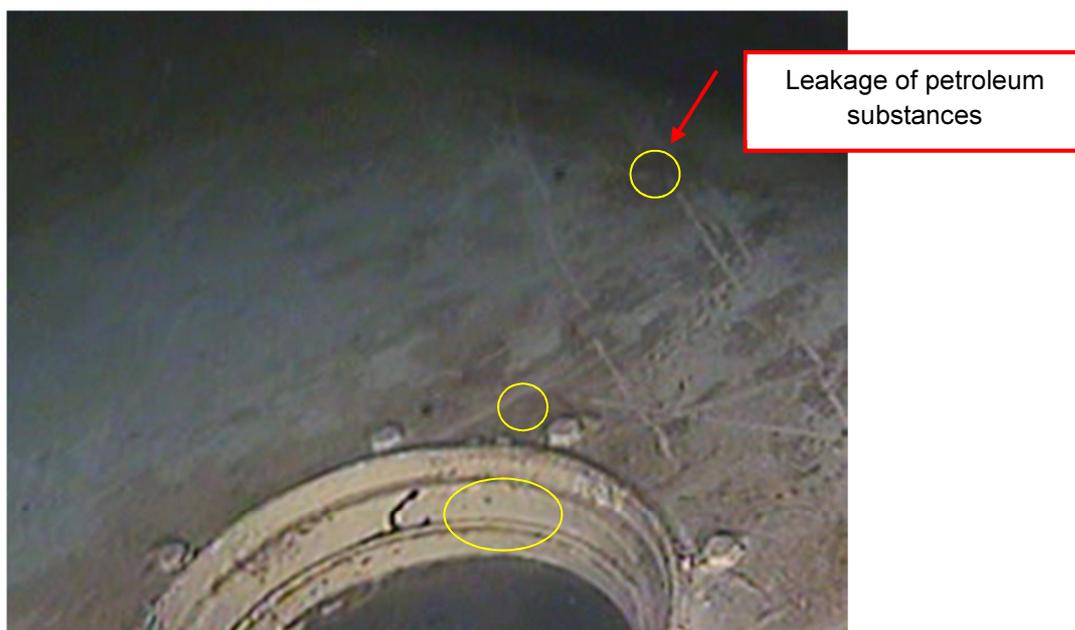
As a result of the inspection of the hull plating, a petroleum substance leakage was detected from one of the wreckage compartments (Fig. 8).

A more thorough investigation has indicated its cause. The leakage source was a porthole. Then, based on the archived video, the leakage scale was estimated and the method of its sealing was developed.

Fig. 8. Leakage of petroleum substances (own studies).

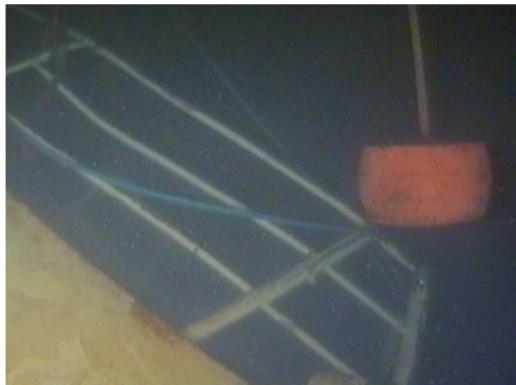
Fig. 9. Location of the diving system anchor in relation to the stern part of the wreck (own studies).

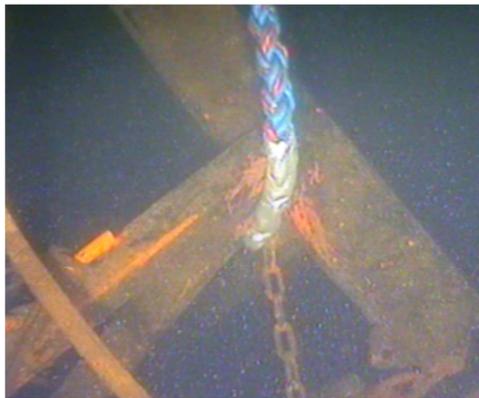
Fig. 14. Wreckage verticalisation operation (own studies):  
A – stretching of the mooring line to the pontoons through the gantry,  
B – fixing of recovery pontoons.
