## **THE SUPPORT OF UNDERWATER WORKS WITH THE USE OF REMOTELY OPERATED VEHICLES ON THE EXAMPLE OF WORKS CONDUCTED ON THE WRECK OF THE FISHING BOAT WŁA-127**

Marek Dawidziuk<sup>1)</sup>, Adam Olejnik<sup>2)</sup>

### **ABSTRACT**

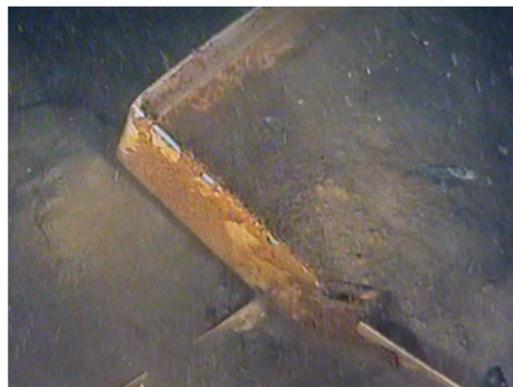
Fig. 3. The object located near the site of the wreck (own studies).

The first stage of work for the ROV operators was to familiarise themselves with the work area, and, in particular conduct an analysis of the collected sonograms for the presence of hazards to the ROV vehicle – such as fishing nets, and a general characterisation of the seabed with the objects present on it (Fig. 3).

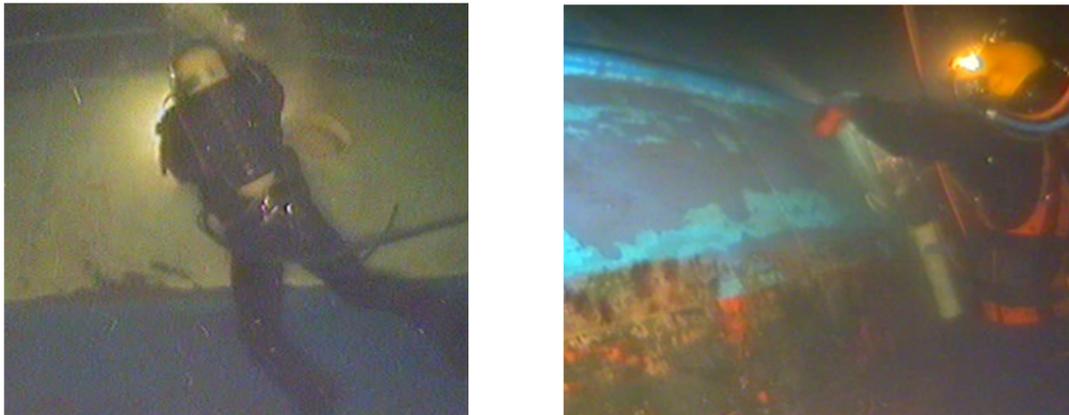
The basic use of vehicles during diving works was to provide the underwater works manager with a current image of the work area with a direct view of the divers (Fig. 10), their activities or situation around

Fig. 10. Technical observation of an underwater diving workstation using the vision system mounted on-board the ROV system (own research).

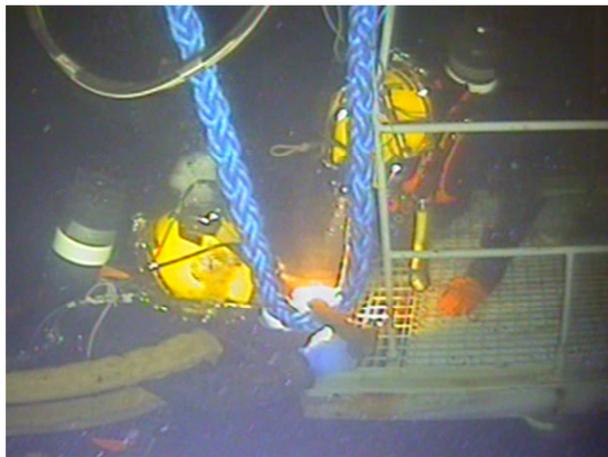
Vehicle lighting was also used during the initial phase of the divers' work. In limited visibility, the orientation of the divers, in relation to their position on the wreck, was significantly impeded, especially when the divers transferred to the work site from the diving platform. To limit the time of divers needed for the orientation in the area and quickly reach the workstation, the operator would in advance guide the vehicle to the workstation and direct the vehicle's lighting towards the diving bell. The presented method of diver guidance was particularly used during works in the area of the vessel's masts (Fig. 11).

Fig. 11. Supervision of activities performed by divers using an ROV (own research).
